GASBUGGY POSTSHOT INVESTIGATIONS IN GB-ER

J. A. Korver

April 19, 1968

TID-4500, UC-35 Nuclear Explosions — Peaceful Applications

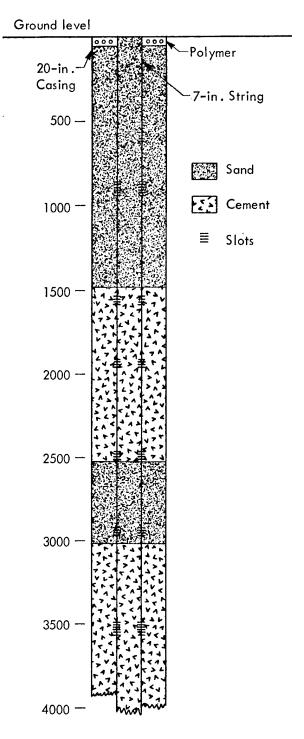
Fig. 1. Emplacement string, 7-in. (preshot configuration).

- 1. Reentry drilling inside the 7-in. casing proceeded with difficulty to 3,000 ft. The difficulty was mainly a result of a failure to stem the hole with cement all the way to the surface preshot. The stemming plan actually used is shown in Fig. 1. This plan was chosen because of concern for the possibility of additional preshot cable failures.

Alamo at 3,550 ft and the radiation spikes, where the casing parted, in the interval 3,790 to 3,870 ft (Fig. 4). In cementing off the slotted sections where there was sand stemming (Fig. 1), the cement did not bond to the casing such that it was gas and water tight. It is likely that a finite permeability existed, preshot, in the stemming as well. Water apparently was able to migrate from the leak at 3,550 ft up to at least 3,260 ft and possibly up as far as

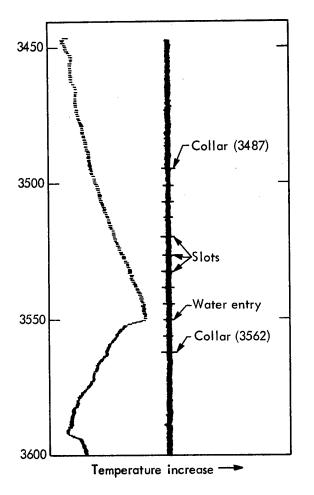
Fig. 2. GB-ER temperature log (1-8-68).

Seven days after drilling stopped and after several short term gas flow tests, a maximum downhole temperature of 152°F was recorded. This is probably not an equilibrium temperature of the rock beyond the reentry hole, but it at least indicates that gas from the chimney is significantly above ambient temperature (125 to 132°F).

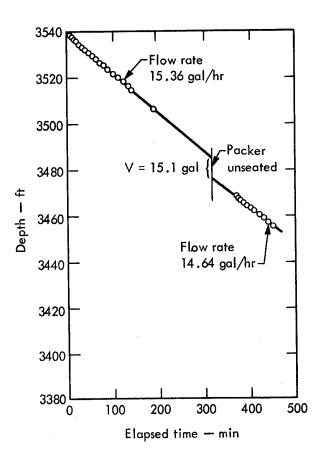
Fig. 3. GB-ER Water level recovery (1-6-68).

The packer was then unseated, while water level measurements continued. The purpose was to see if another water entry was occurring through the upper slots near 950 ft. A slight jump in the water level was noted when the packer was unseated at 10:42 p.m. The rate of rise in the water level, however, did not change from what it had been prior to unseating the packer. The indications were then, that there was no significant leak from the upper slots and that the water coming in was water left behind from drilling. In fact, the flow rate computed from the water rise after unseating the packer was 14.64 gal/hr, whereas the flow rate before unseating was 15.36 gal/hr. The amount of fluid added to the hole when the packer was unseated was about 15.1 gal. Fluid levels were recorded after unseating, and continued until 12:57 a.m. on January 8. The final level recorded was 3,455.0 ft. Figure 3 is a plot of the data, showing water level as a function of time.

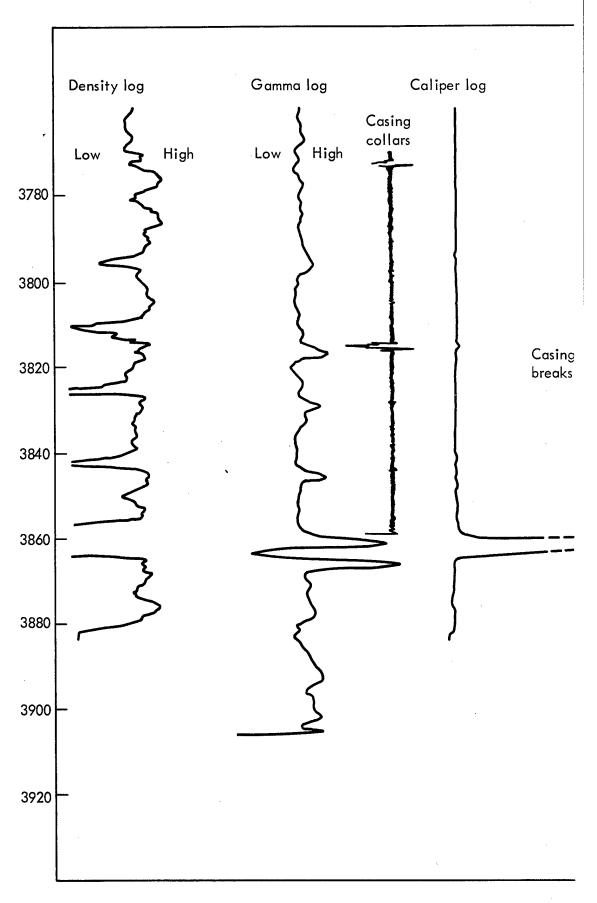
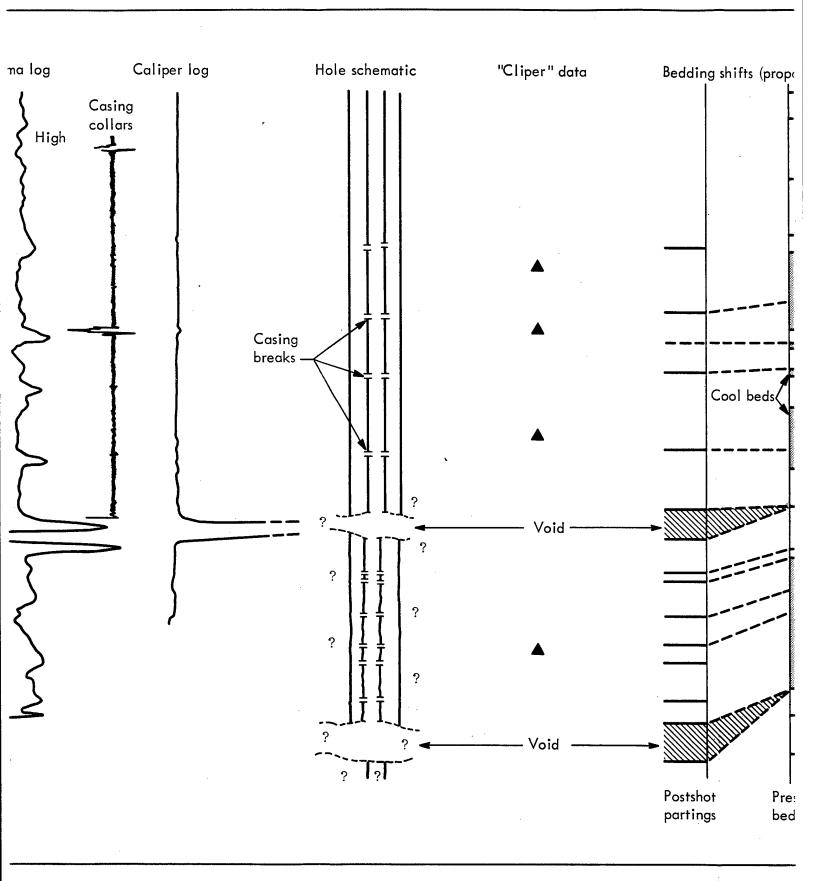
Fig. 4. Postshot characteristics.

Figure 4 illustrates the casing breaks found in GB-ER and a proposed correlation

of these breaks with preshot bedding plane "weaknesses" interpreted from the density log of the emplacement hole. The correlation is not conclusive, but is suggestive of breaks due to slight shifts or tensional openings along the boundaries of rock with different densities. Also shown are the breaks of the "cliper" cables in Hole GB-1. The extent, location, and frequency of the breaks also suggests failure along rock boundaries. Figure 7 is a plot of the "cliper" data with density log in GB-E. This further illustrates the correlation between breaks and the locations of major density changes or bedding plane boundaries. The relative depth uncertainty of the cable breaks is about ±1 ft, the absolute depth is uncertain to ±10 ft.

A density log, run later in this interval (3,500 to 3,862 ft), showed low density spikes at the following, approximate depths: 3,817, 3,826, 3,843, and 3,851 ft. These spikes can be interpreted as breaks in the 7-in., and possibly in the 20-in. casings. A caliper log run simultaneously with the density log showed small offsets in the 7-in. casing at approximately 3,815, 3,826, and at 3,843 ft. At 3,857 ft the caliper measured a hole at least 14 in. in radius. Also, since a magnetic collar locater, which was run in the area of the water leak showed the casing slots so well, the locator was run again here to see if it would show casing breaks. The log performed well in showing the casing irregularities (see Fig. 4).

A formation density log was run, but as with the gamma log, the bad hole conditions below 3,862 ft prevented the tool from going lower than 3,886 ft. As can be seen in Fig. 4, the low density areas on this log correlate well with the high radiation areas on the gamma log.

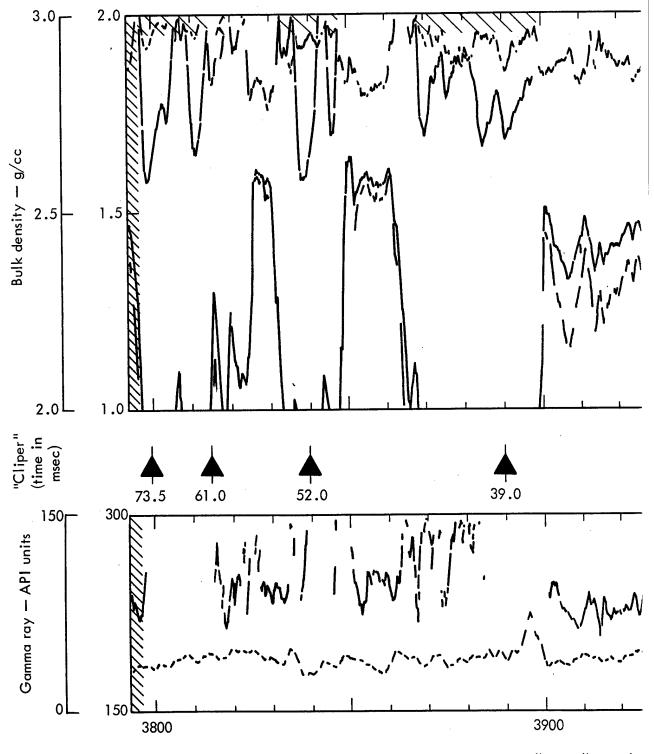
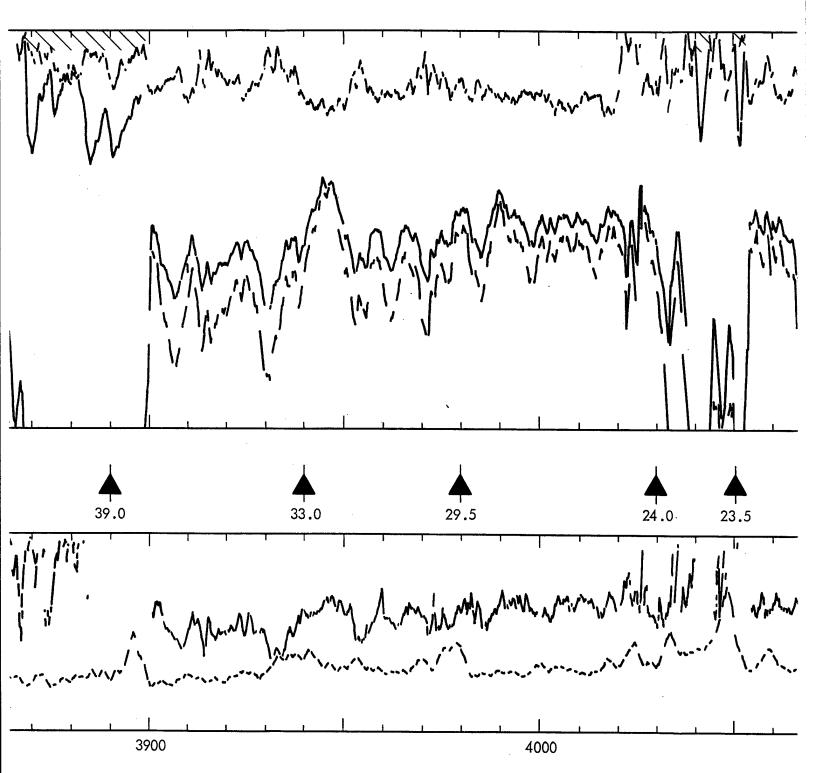
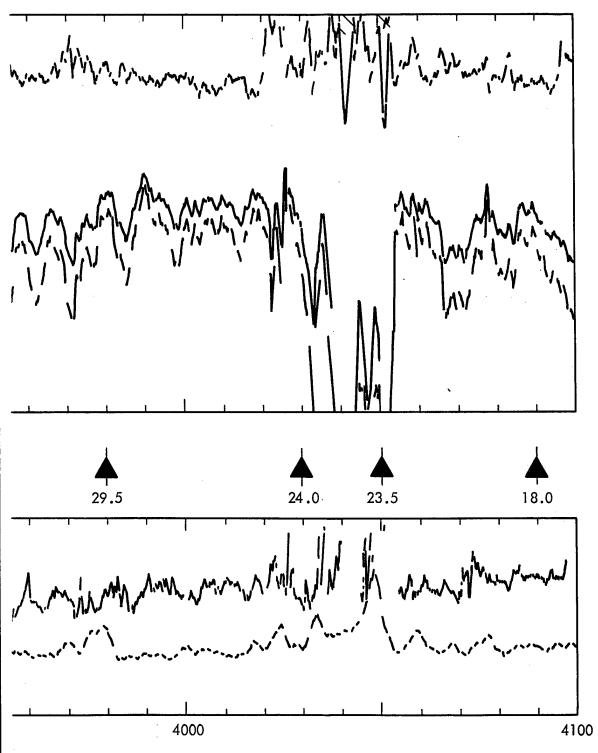
Fig. 7. "Ciper" data (GB-1) plotted with density (GB-E),

The geophone evidence indicates that the chimney formed during the first minute following the explosion. The "cliper" data on cable breaks in Hole GB-1 indicated failure out to a radial range of 480 ft which occurred at about the time of passage of the outgoing stress wave from the explosion.

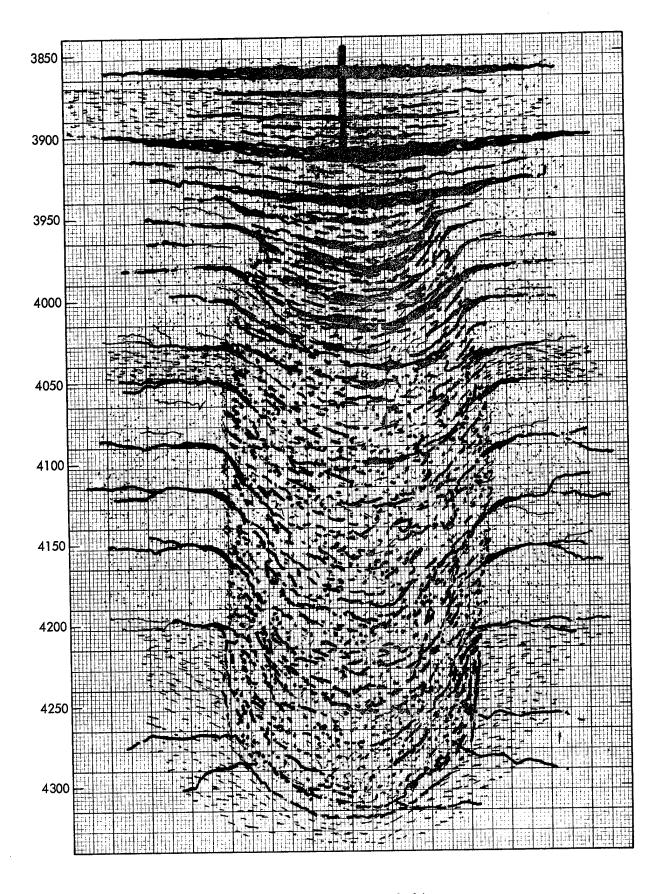
Fig. 8. Gasbuggy—proposed chimney.

Prior to the shot, it was the author's judgment that if chimneying propagated through the Pictured Cliffs formation, such propagation would continue through the coal section to a depth of approximately 3,800 ft. 4 We now postulate that sufficient bulking in the chimney occurred within the Pictured Cliffs formation so that there is no large apical void and the overlying material has sagged and parted along pre-existing weaknesses. This overlying material was further weakened by the stress wave at shot time and failed in tension with the chimney development. With this hypothesis, the upper portion of the chimney is different from previous experience; it is a broad transitional zone from rubble with nearly infinite permeability to rock with very little increase in permeability. We suspect that GB-ER was not drilled deeply enough to get into chimney rubble with nearly infinite permeability. Figure 8 is a schematic drawing of this concept.

The predicted radius of fracturing of 425 ft is close to the 480-ft radius (cliper data GB-1) and the furthest casing break in GB-ER of 444 ft. The chimney was expected to terminate at a distance of 334 ft above shot point, or in the region of the lower void found in GB-ER. This is, indeed, where communication with the chimney occurred, and it could be very near the chimney top.
